RESTORATION IN THE RUSSIAN RIVER

Sean White

Sonoma County Water Agency

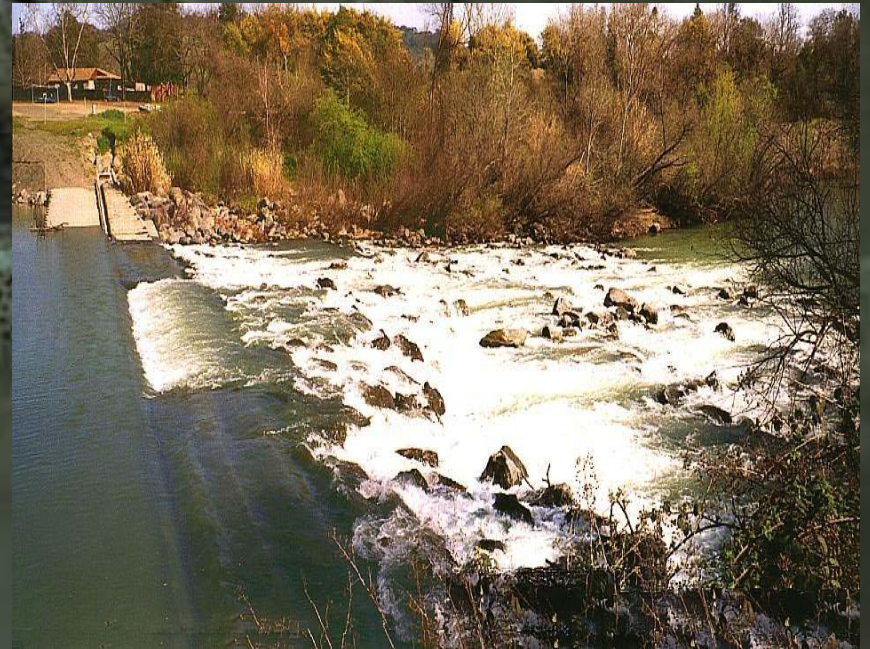
Healdsburg Dam Fish Ladder

- **Seasonal flashboard dam**
- **Mainstem of Russian River**
- **Constructed in 1953 as a WWII Veterans memorial**
- **Low-flow barrier**

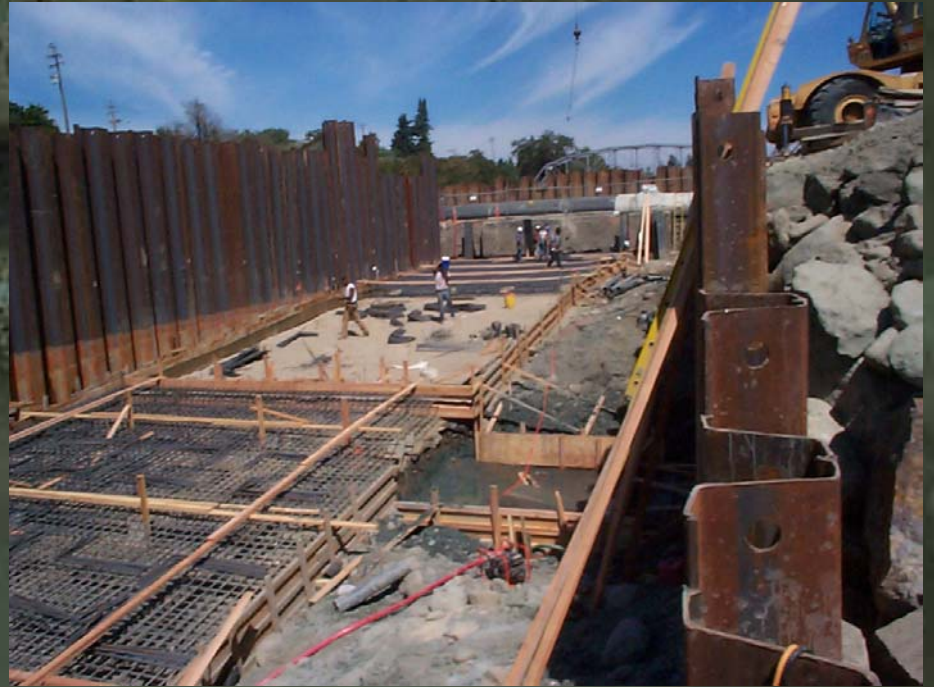
Healdsburg Dam Fish Ladder

- **Restore full access to almost 800 square miles of habitat**
- **Construct 13 step “Ice Harbor” style fishway**

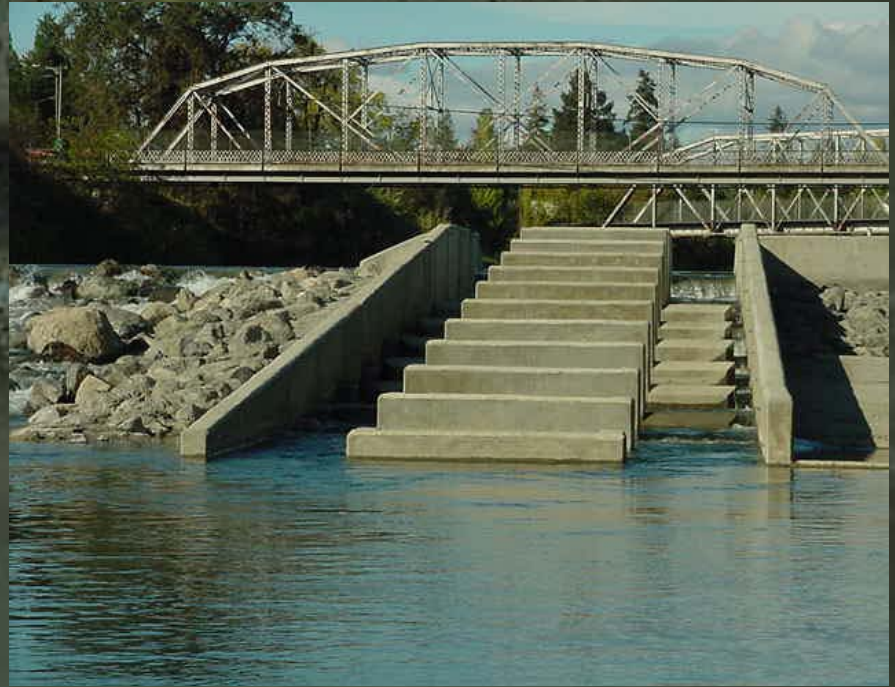
Healdsburg Dam Fish Ladder

- **Completed summer of 2001**
- **Major benefit to Chinook salmon**
- **Over 1000 redds above fishway in 2002**

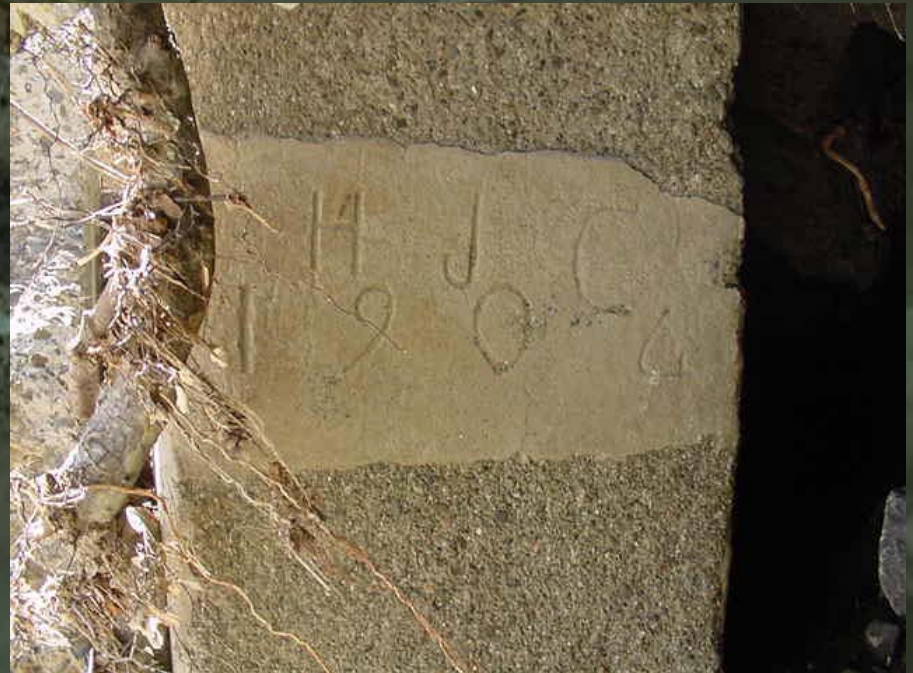
Crocker Creek Dam Removal and Riparian Restoration

- **Background**
- **Built in 1904 for swimming**
- **Final configuration over 30 feet high with 3 spillways**
- **Dam failed during El Nino flows of 1997**

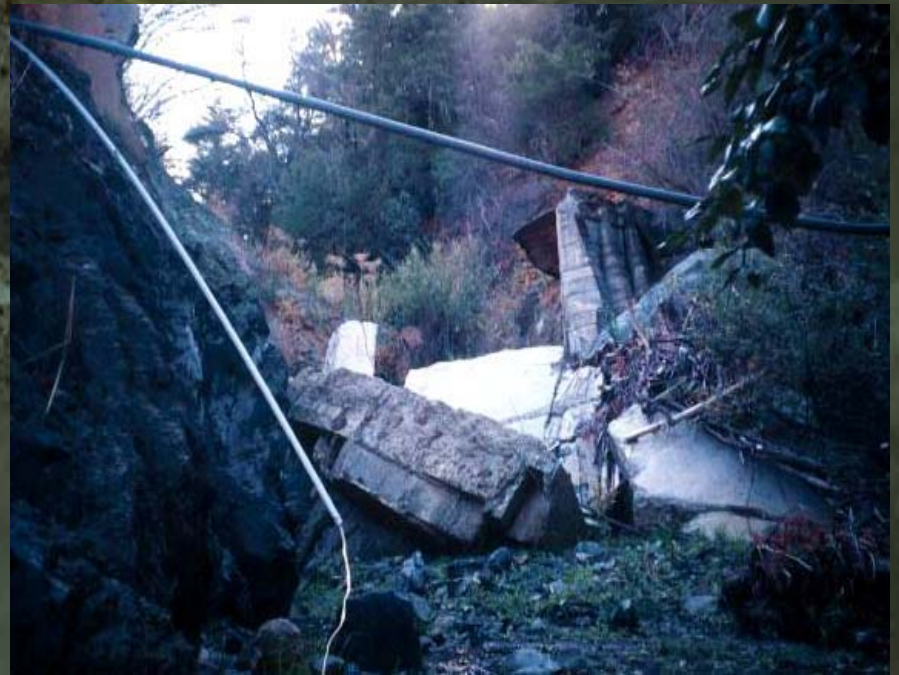
Crocker Creek Dam Removal and Riparian Restoration

- **Restore access to 5 miles of stream**
- **Stop acute release of stored sediments**
- **Stabilize and revegetate upstream bank failure**

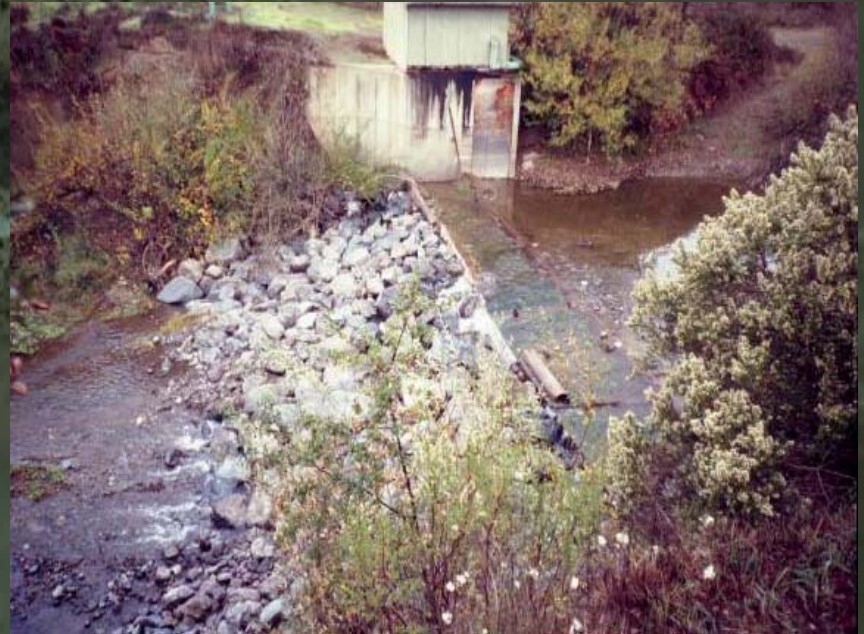
Mumford Dam Fish Passage and Riparian Restoration

- **Flashboard Dam built in 1908 for recreation**
- **Currently used for vineyard frost protection**
- **Headcut at base 14 feet below historic grade**

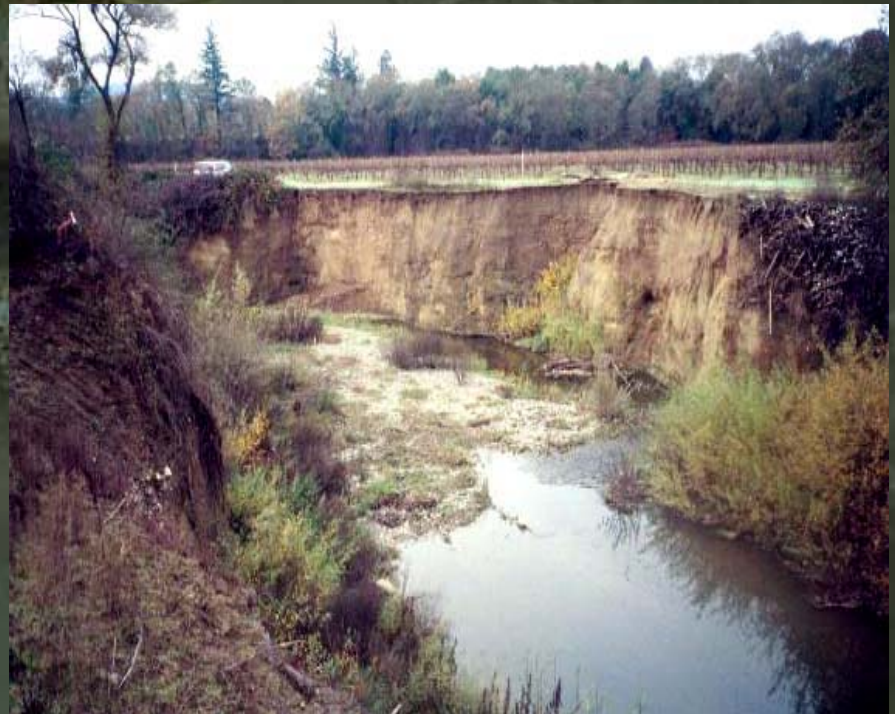
Mumford Dam Fish Passage and Riparian Restoration

- Use rock weirs to restore access to 50 miles of stream
- Stabilize and revegetate downstream bank failure
